E-Water

## **The Causes and Mechanisms of Historical Dike Failures in the Netherlands**

Dr. S. Van Baars  
Assistant Professor Soil mechanics

Faculty of Civil Engineering and Geosciences  
Delft University of Technology

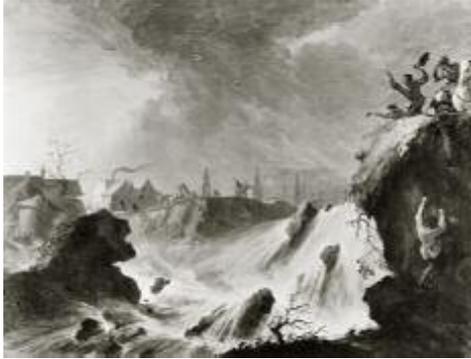
Fig. 1 St. Anthonis dike failure during St. Peter's flood, P. Nolpe, 4-5 March, 1651

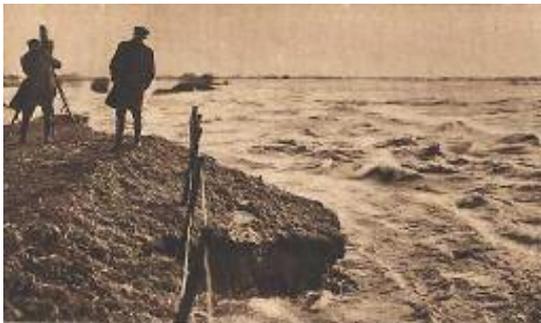
Fig. 2. Overflow of dike along the river Maas after heavy rain, Nederasselt, 8 January, 1925

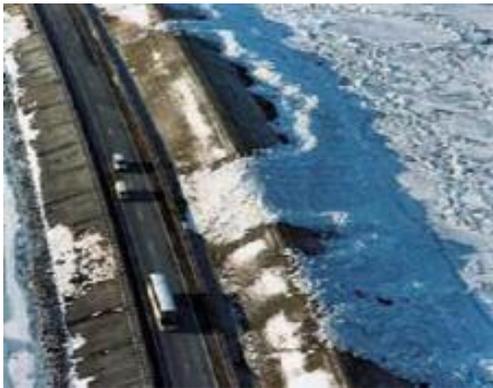
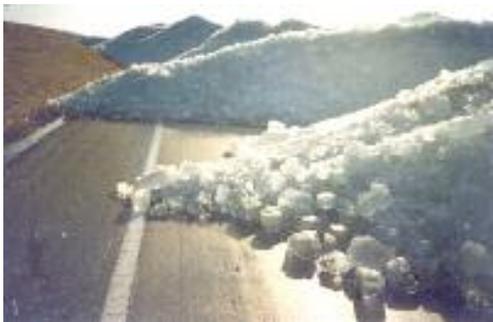
The failure of sea dikes caused by ice is different from the failure of river dikes caused by ice. Ice piles up on the sea dikes as floating ice is blown in by the wind.

Fig. 3. Ice drift on the IJsselmeer Dam

Fig. 4. Ice drift on the IJsselmeer Dam

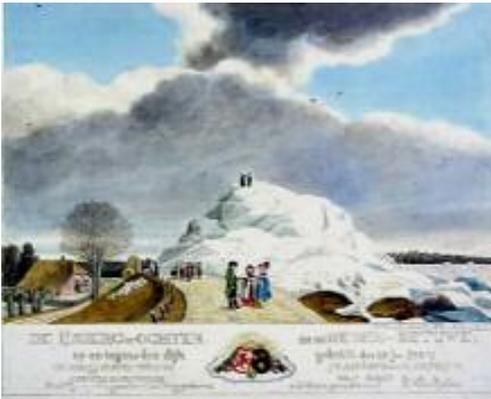
Fig. 5. “The iceberg of Ochten (a village along the river Rhine) ... detonated on 24 January, 1789”

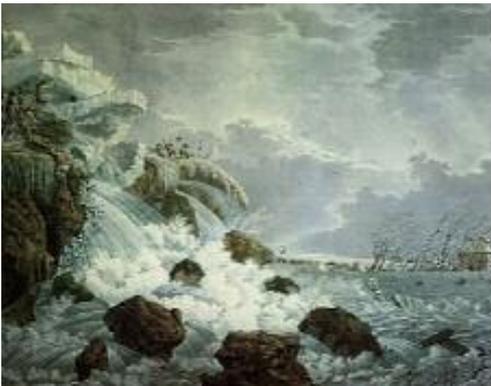
Fig. 6. Dike failure cause by ice in 1799

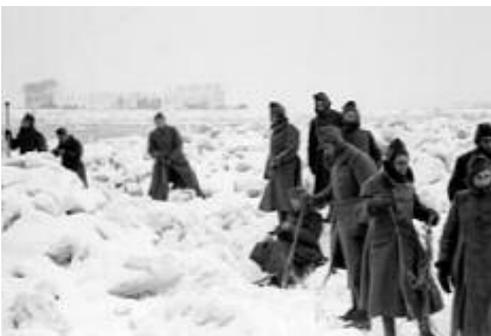
Fig. 7. Men trying to reduce the ice load on a dike

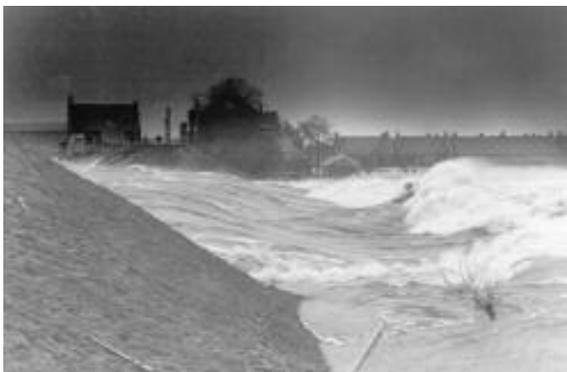
Fig. 11. Collapsed dike, Papendrecht 1953

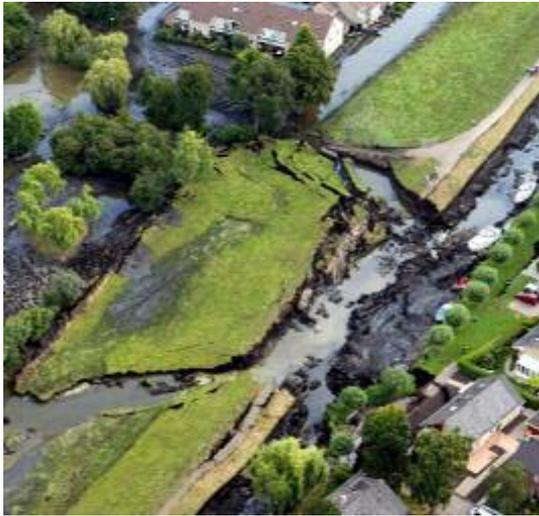
In 2004 the government proposed compiling a new list (VTV, 2004). However, this list still omits mechanisms H and N (even ship collision), but this time also fails to include mechanisms L and M. Mechanism “L, Horizontal sliding” is, since 1999, believed by the Dutch government to be impossible, but the peat dike failures near Zoetermeer (1947, Oostzaan (1960), Wilnis (2003), Terbregge (2003) and the levee failures in New Orleans (2005) have proven this mechanism to be possible (Van Baars, 2003). The government considers that mechanism M “Ice drift” no longer poses a threat. This is not correct. Even though river water temperatures have increased over the years and the ice drift

Fig. 12. Horizontally shifted peat dike, Wilnis 2003
